# Product Support Bulletin

Subject: DFX-5000 paper loading problems.

PSB No: P-0102

Subject: DFX-5000, DFX-8000 and Avatar EP-Connect

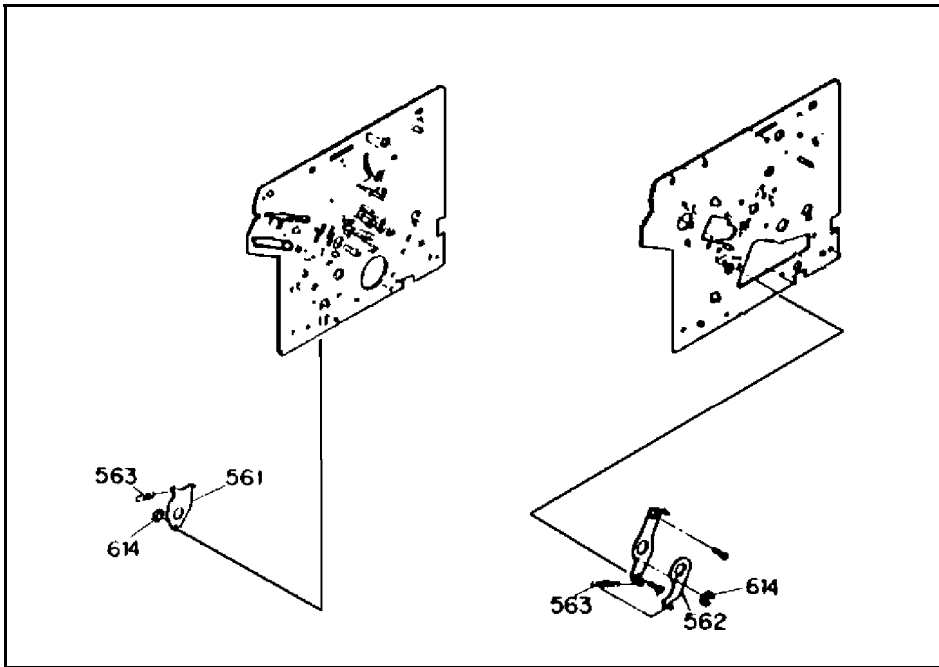
**Figure 1**

If the PGM backlash adjustment does not cure the problem, there are two friction clutches that keep the CGS from rotating while printing. On older units, or units used in harsher environments, the lubricant on the friction plates will dry out or get contaminated causing sluggish response of the CGS. The CGS will seem like it is harder to turn than other printers, although the amount is very slight and is difficult to measure.

On each side of the CGS there is a friction clutch (Figure 1, Reference 561, 562, 563 and 614). These clutch plates must be removed, cleaned, lubricated and reinstalled.

1. Remove the interlock switch before lifting the mechanism out.
2. Remove the four screws that hold the mechanism in the printer, all cables and ground straps.
3. Remove the junction board, the PG sensor and the PG motor.
4. Remove the E ring that holds the CGS gear and the other small gear.
5. Remove the E ring (563) and spring (614) that attaches the "Guide shaft holding lever" or clutch plate.

6. Clean the plate and the end of the CGS. Lube the assembly with light machine oil (Epson 02 oil).
7. Do the same for the right side by first removing the carriage motor.

8. Remove the E ring and spring that attaches the “Guide shaft holding lever” or clutch plate.
9. Mark the parallelism adjustment plate and remove the two screws that attach it.
10. Clean the plates and the end of the CGS. Lube the assembly with light machine oil
11. Assemble in reverse order, do the PGM backlash adjustment, check and perform the parallelism adjustment if necessary and test.
