# EPSON PRODUCT SUPPORT BULLETIN

| <b>TIB #:</b> | PSB.2009.06.002 | <b>Authorization:</b> | Kps |
| <b>Subject:</b> | Release of EMP NS Connection for Windows & Mac Upgrade from v2.50 to v2.51 | | |

| <b>Product(s):</b> | PowerLite 735c / Cinema 500 / 737c / 745c / 755c / 765c / 830p / 835p / 1705c / 1715c / 6100i / 6110i / 7800p / 7850p / 7900NL / 8300i / 8300i with EasyMP.net module / 9300NL / 1815p / 1825 / 822p / 83c / 822+ / 83+ / G5000 / Pro G5150 / Pro G5350 / Pro G5200W / 1725 / 1735W / 400W / 410W / 84 / 85 / 825 / 826W<br>PowerLite 61p / 81p / 82c / 821p / 1810 / 260d (Latin America) / 280d (Latin America) with TCP/IP to Serial converter | | |

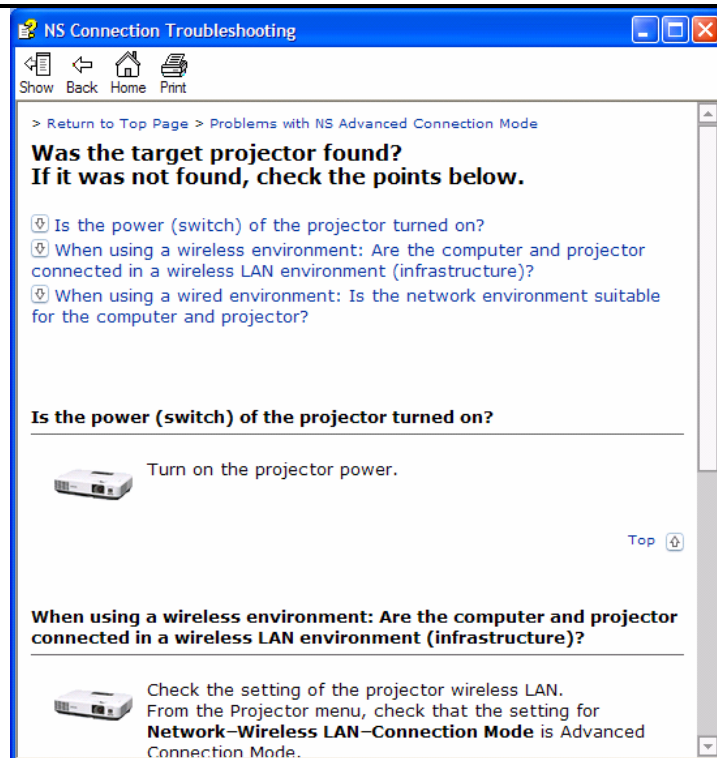
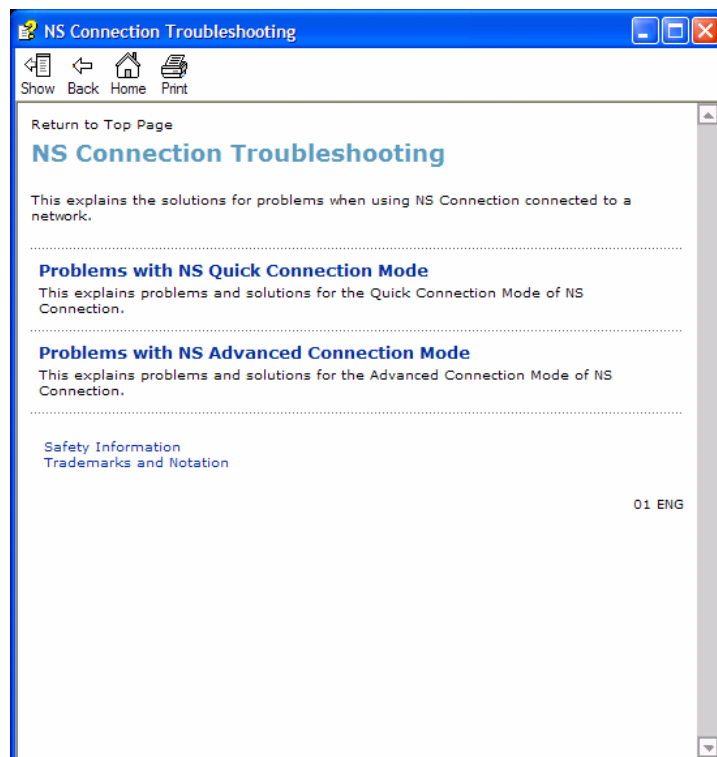
| Improvements | |
|---|---|
| | <ul style="list-style-type: none"><li>■ Addition of 10 new languages: Arabic, Ukrainian, Romanian, Indonesian, Croat, Slovak, Bulgarian, Malay, Vietnamese and Hebrew.</li><li>■ Addition of troubleshooting function (Windows Only)<br/>When pressing the troubleshooting button, the corresponding troubleshooting and error number is displayed in the error message window.<ul style="list-style-type: none"><li>• When experiencing problems with NS Connect, please report to Epson the error number along with the failure information.</li></ul></li></ul> |

Also you can access troubleshooting by clicking **Start → All programs → EPSON Projector→EMP NS Connection→EMP NS Connection V2.51 Troubleshooting.**

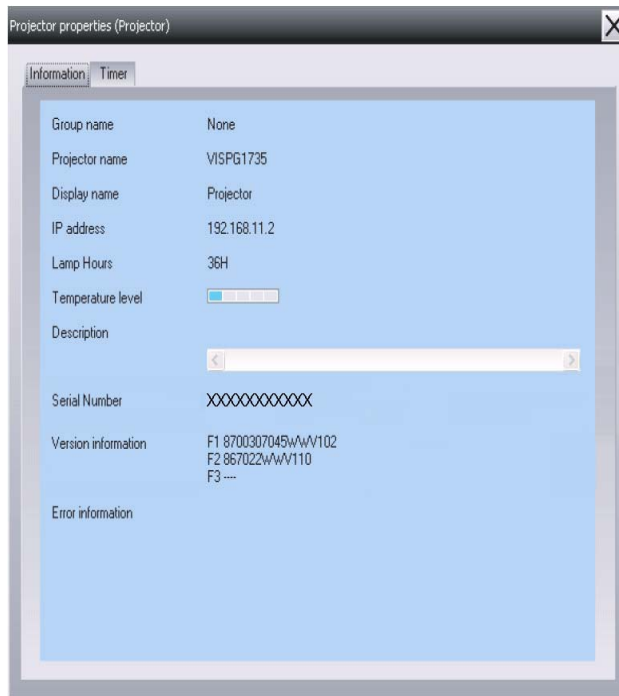
(3) New feature for the PowerLite 84 / 85 / 825 / 826W.

Displays projector's serial number in the Menu settings

- The projector's serial number is now displayed in the projector's menu under "info",
- EMP Monitor can also display the projector's serial number as shown below:
