# EPSON PRODUCT SUPPORT BULLETIN

| <b>TIB #:</b> | PSB.2009.06.002 | <b>Authorization:</b> | Kps |
| <b>Subject:</b> | Release of EMP NS Connection for Windows & Mac Upgrade from v2.50 to v2.51 | | |

| <b>Product(s):</b> | PowerLite 735c / Cinema 500 / 737c / 745c / 755c / 765c / 830p / 835p / 1705c / 1715c / 6100i / 6110i / 7800p / 7850p / 7900NL / 8300i / 8300i with EasyMP.net module / 9300NL / 1815p / 1825 / 822p / 83c / 822+ / 83+ / G5000 / Pro G5150 / Pro G5350 / Pro G5200W / 1725 / 1735W / 400W / 410W / 84 / 85 / 825 / 826W<br>PowerLite 61p / 81p / 82c / 821p / 1810 / 260d (Latin America) / 280d (Latin America) with TCP/IP to Serial converter | | |

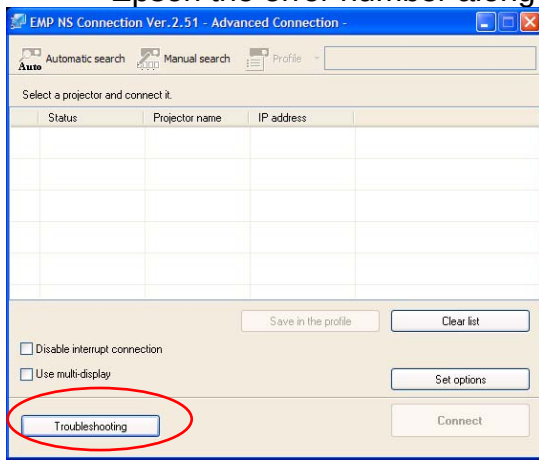
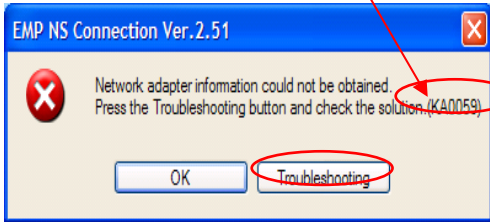
| Improvements | |
|---|---|
| | <ul style="list-style-type: none"><li>■ Addition of 10 new languages: Arabic, Ukrainian, Romanian, Indonesian, Croat, Slovak, Bulgarian, Malay, Vietnamese and Hebrew.</li><li>■ Addition of troubleshooting function (Windows Only)<br/>When pressing the troubleshooting button, the corresponding troubleshooting and error number is displayed in the error message window.<ul style="list-style-type: none"><li>• When experiencing problems with NS Connect, please report to Epson the error number along with the failure information.</li></ul></li></ul> |

Also you can access troubleshooting by clicking **Start → All programs → EPSON Projector→EMP NS Connection→EMP NS Connection V2.51 Troubleshooting.**
